REC-ERC-81-7

PERFORMANCE OF GRANULAR SOIL COVERS ON CANALS

**Engineering and Research Center
Bureau of Reclamation**

August 1981

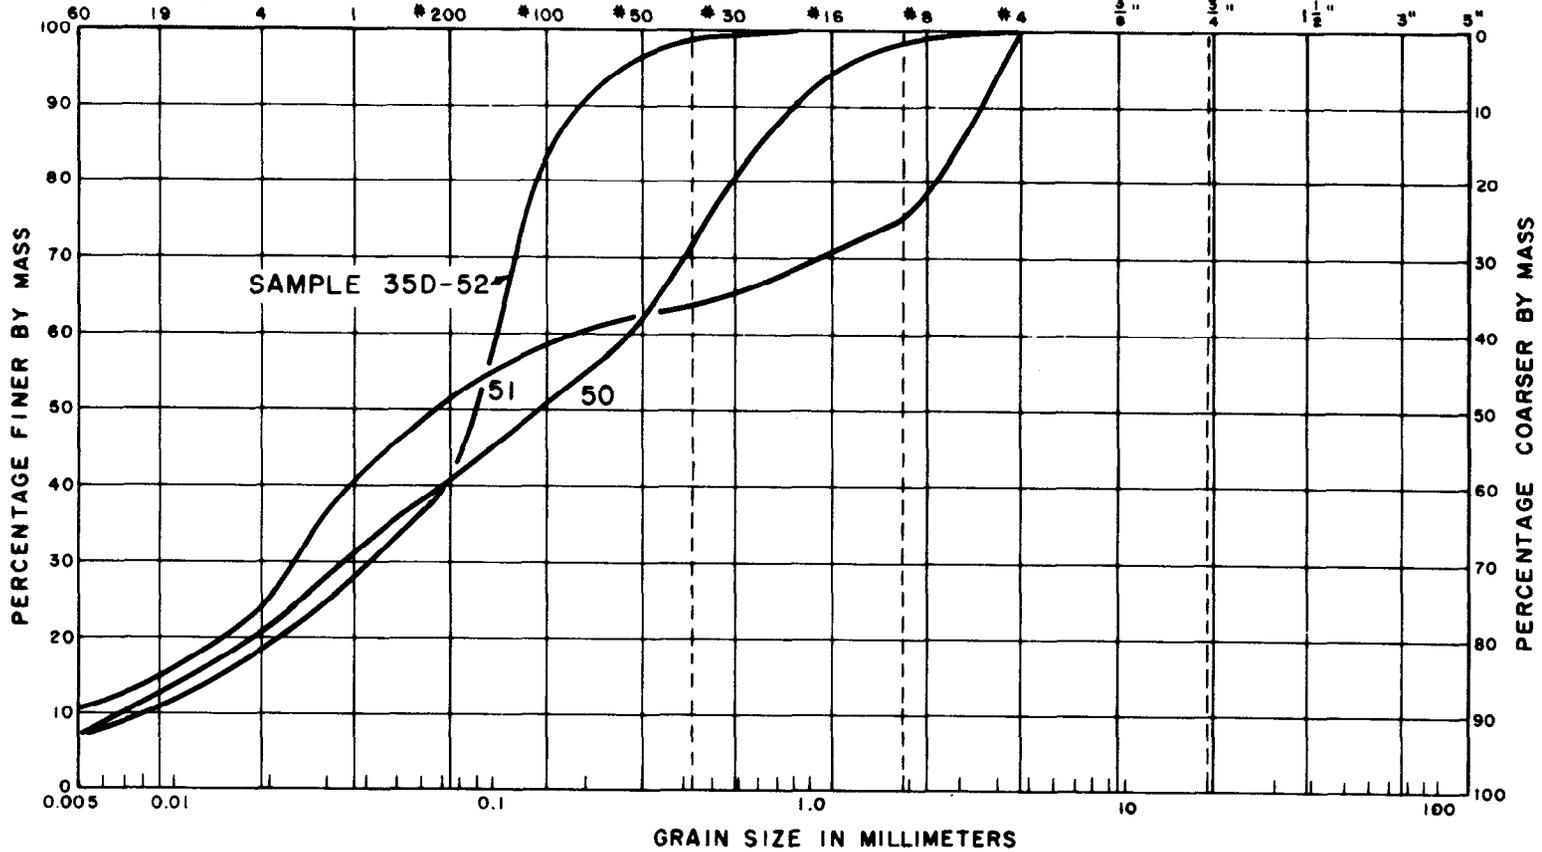
The silty sand cover had a wide variation in sand sizes (fig. 8). When inspected in 1960, this cover had a thickness from 0 to 350 mm (0 to 14 in) and was rated in poor condition. There had been a considerable amount of erosion and an unusual amount of maintenance was required with the addition of coarse material to reduce erosion. Figures 9 and 10 show the condition of the lateral in 1978. With maintenance, the cover had apparently become stabilized. However, this soil is too fine for a stable, maintenance-free cover to protect a membrane lining. Also, the side slope were steeper than the 2:1 usually recommended.

Figure 8. — Gradation of single cover layer on lateral W22E.

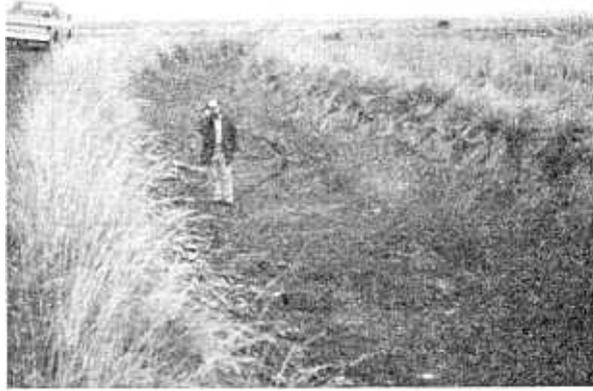
Figure 9.—Lateral W22E between farm units 89 and 90.
November 1977 Photo P801-D-79524

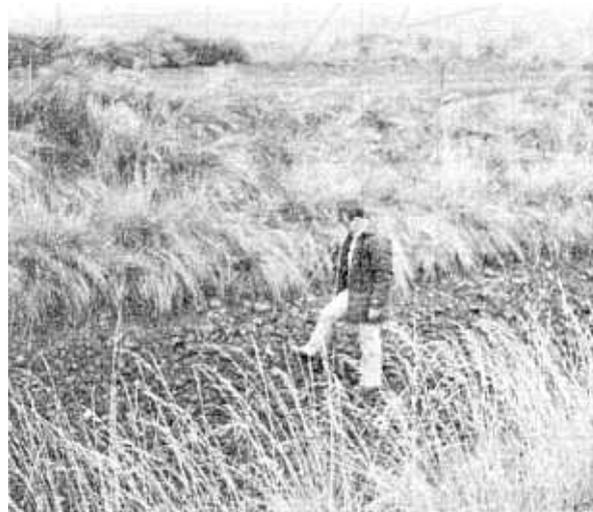
Figure 10.—Left bank of lateral W22E between farm units 74
and 75. November 1977 Photo P801-D-79554

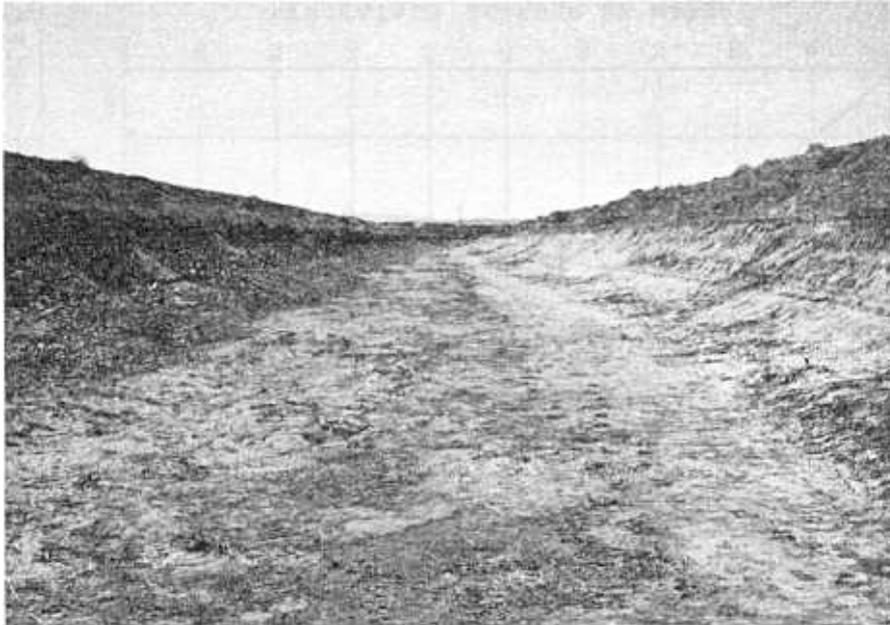
Figure 15. — Wyoming Canal looking upstream from station 376+43 m (1235+00 ft).
April 1978 Photo P801-D-79530

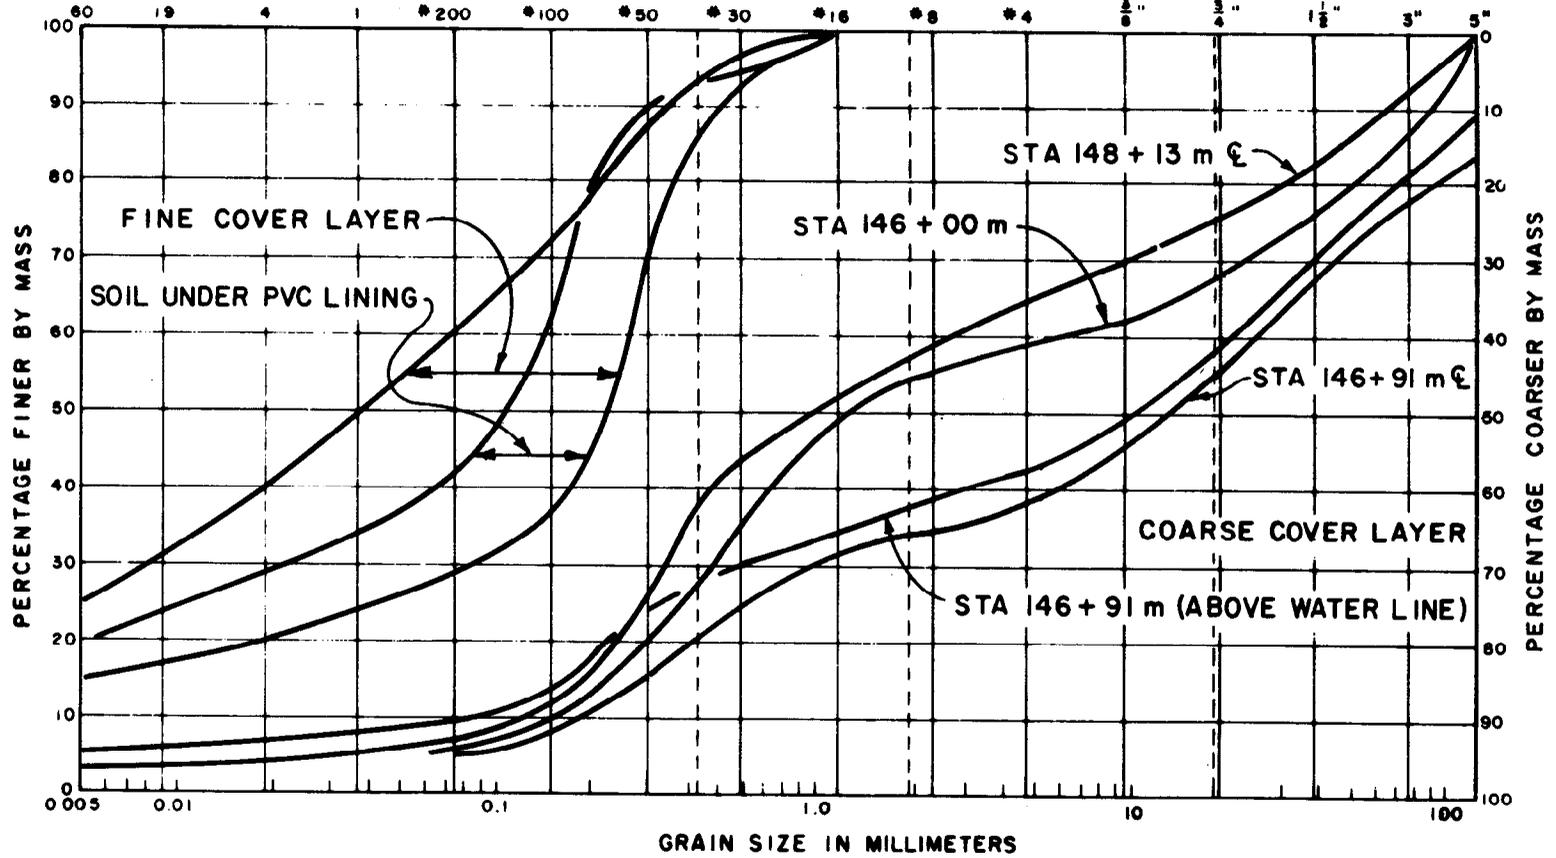
Figure 28. — Gradations of cover layer and underlying soil for polyvinyl chloride membrane lining on the Wyoming Canal - stations 146 + 00 to 148 + 13 m (479 + 00 to 486 + 00 ft).

Although the cover on the PVC lining on the Wyoming canal between stations 146+00 and 148+13 m (479+00 and 486+00 ft) has generally shown good performance, there was some slippage after the water was turned into the canal. The grading of the coarse layer (fig. 28) at stations 146+00 and 148+13 m extended slightly above the upper stable limit as shown in figure 47 in the medium to coarse sand range. Also, the design tractive force, 5.7 Pa (0.12 lb/ft^2), was higher than for most of the other canals investigated.

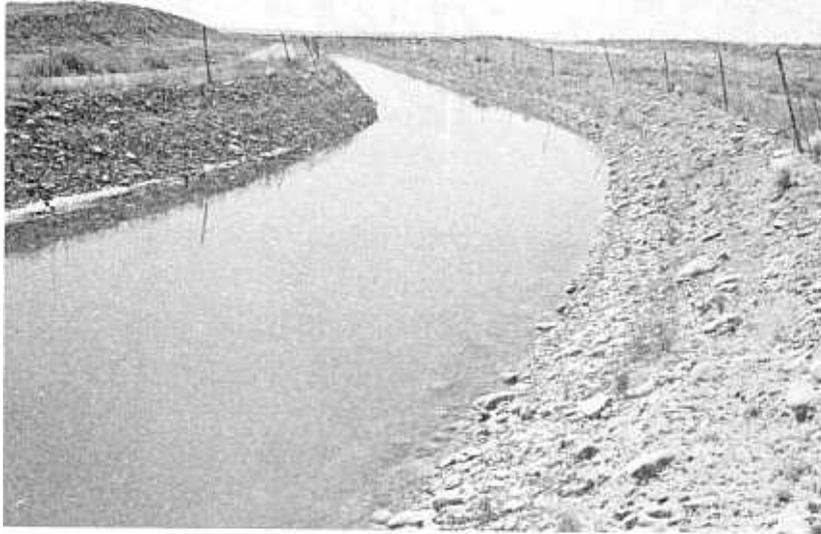
Figure 34.—Amarillo Canal looking upstream from station 183+79 m (603+00 ft) in section 5A. August 1980 Photo P801-D-79545

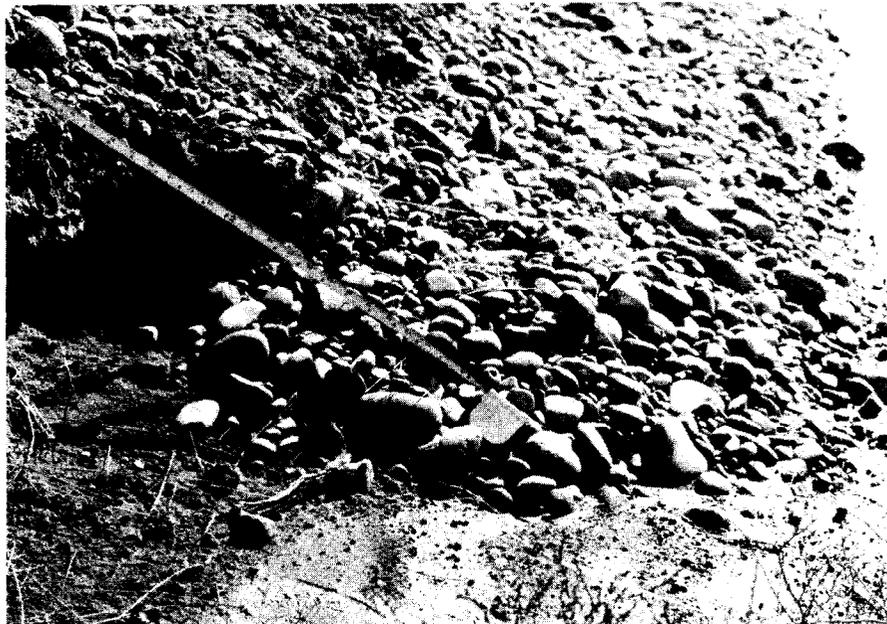
Figure 41.—Start of 150-mm (6-in) gravel cover on embankment for Kennewick Main Canal test section. March 1954 Photo P801-D-79539

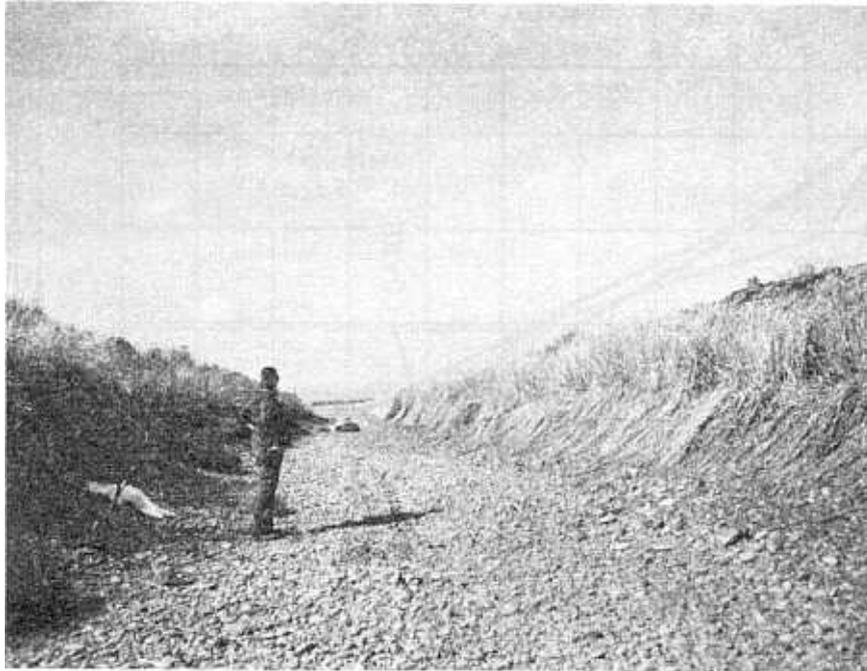
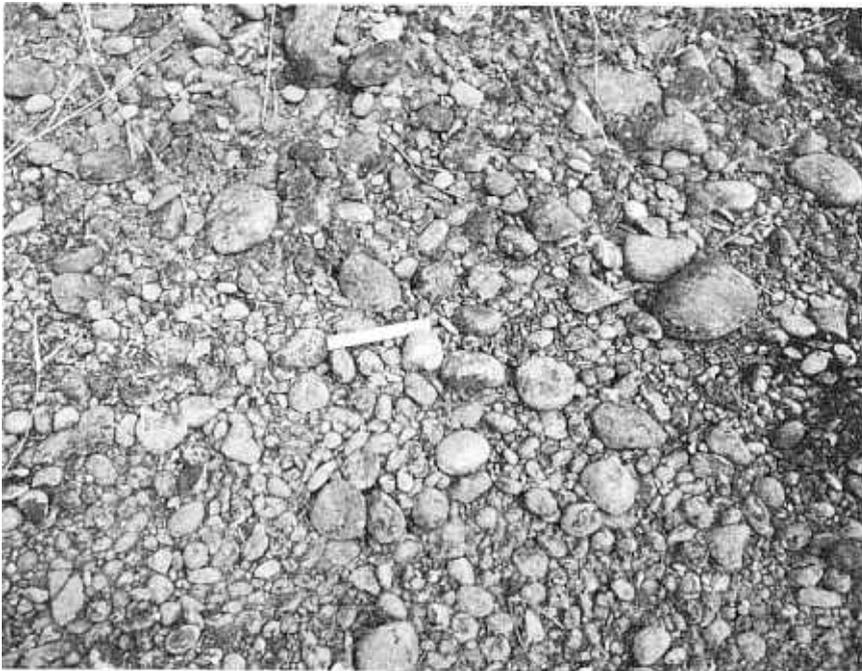
Since canal construction in 1955, the cover has required little maintenance, and during an inspection in March 1978, it was considered to be in good condition (fig. 42).

Figure 42.—Distant and close views of Kennewick Main Canal at station 74 + 98 m (246 + 00 ft). March 1978 Photos P801-D-79541 and P801-D-79549

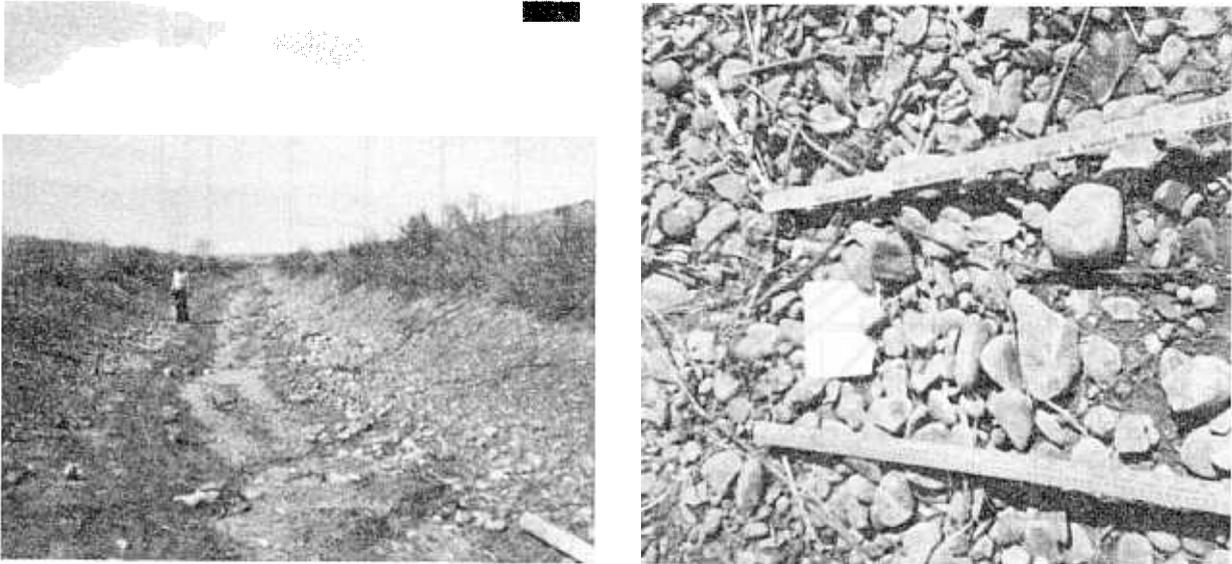
Figure 44. — Distant (left) and close views of cover on Atrisco Feeder Canal at station 147+83 m (485+00 ft). November 1977 Photos P801-D-79536 and P801-D-79540

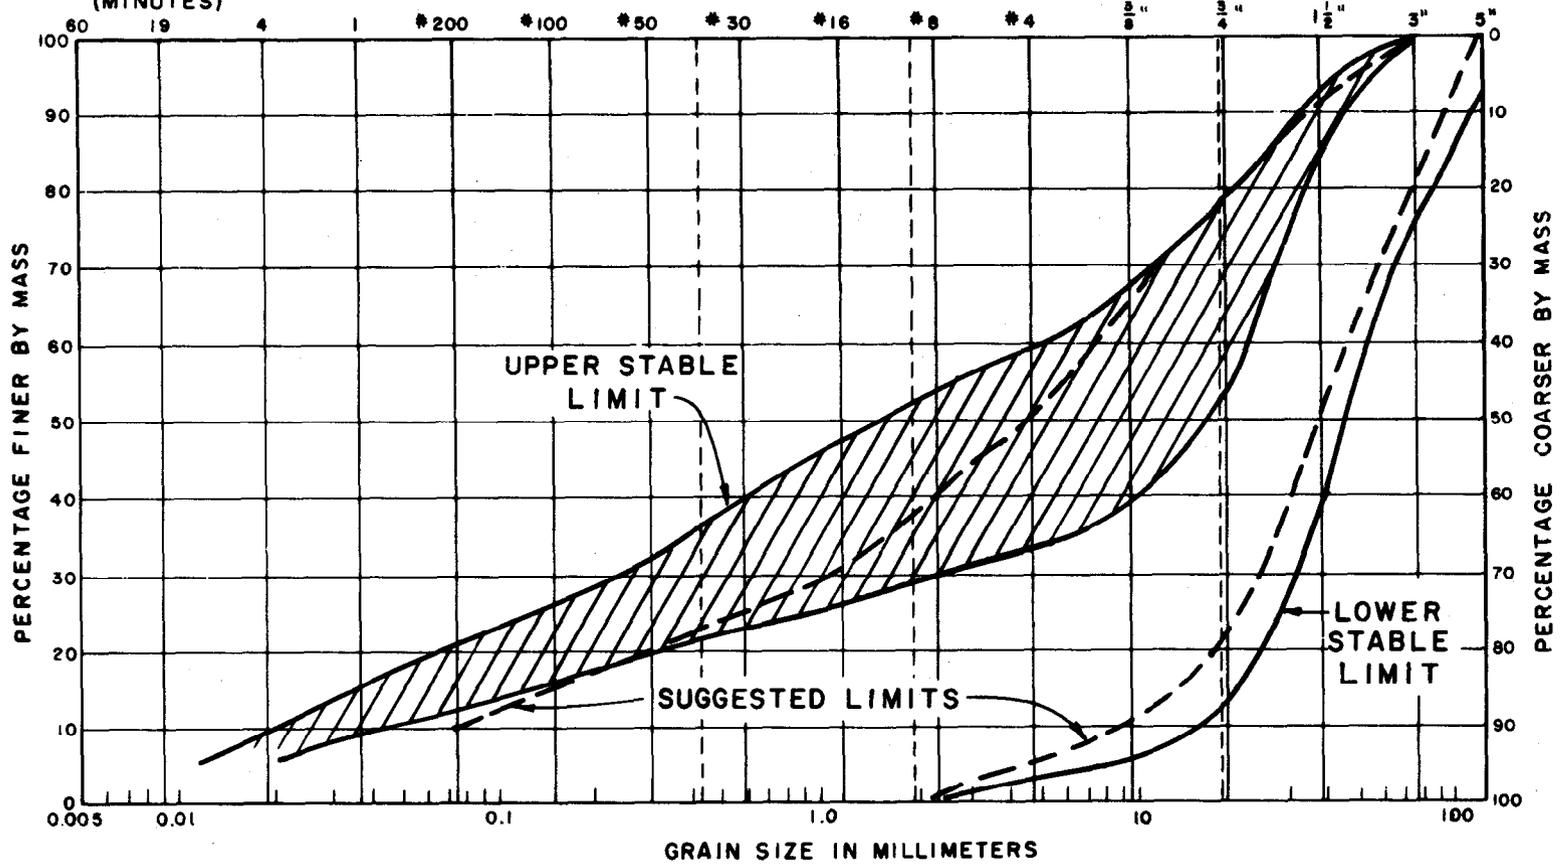
Most of the gradings of stable coarse covers investigated fell within the upper and lower limits shown in Figure 47. Gradings of covers with poor stability were generally above the upper limit but some fell below this limit into the shaded overlap area. An overlap would be expected because of variable soil, design, operating, and climatic conditions. The individual gradings, from which the plot was made, were obtained on samples after the canals had been in operation for some time and may not reflect the original grading of the cover as placed because of infiltration of fines. The stability of gravel with infiltrated fines would be higher than if the fines had been present during cover placement. For these reasons some of the gradings for gravels with a large amount of fines, such as those from the West Canal 5th Section, of the Columbia Basin Project, which have proved to be stable, did not fall entirely within the stable grading range as shown.

Figure 47.— Gradation ranges for good to poor performance of coarse soil cover layers with suggested new limits.
